ANNUAL LANDFILL INSPECTION REPORT

**Sunflower Electric Power Corporation
Holcomb Station Unit #1
2440 Holcomb Lane / P.O. Box 430
Holcomb, KS 67851**

January 5, 2023

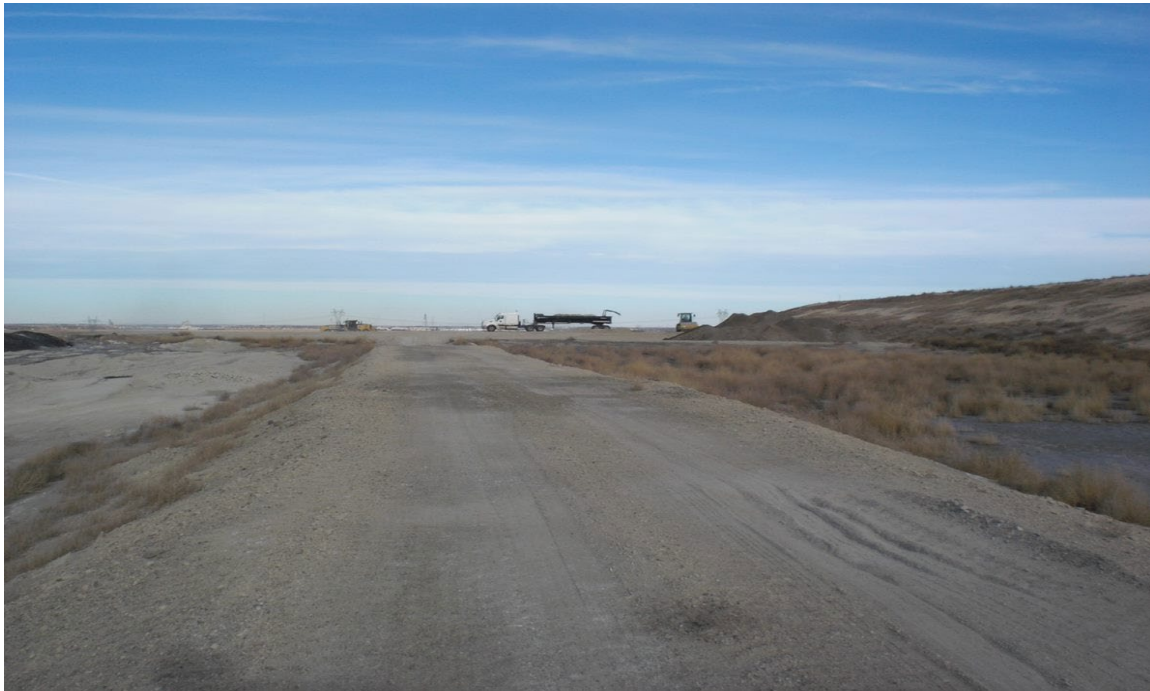
Photo 2: Phase 3A looking east. On top of waste pit.

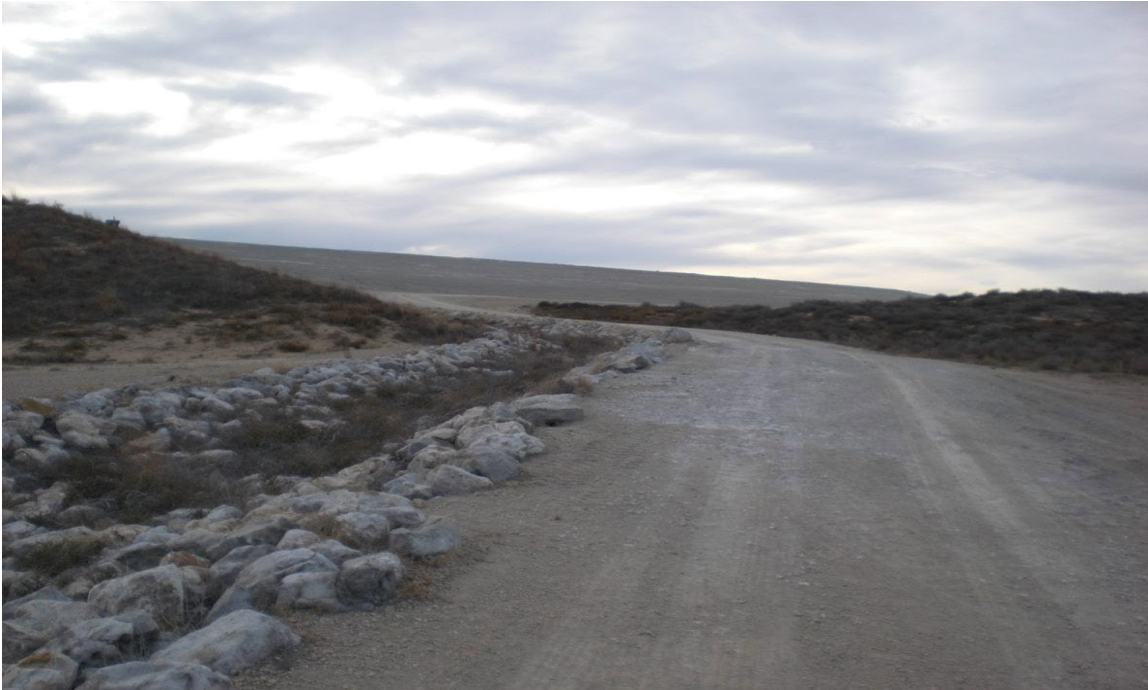
Photo 3: Contact water ditch for Landfill looking west

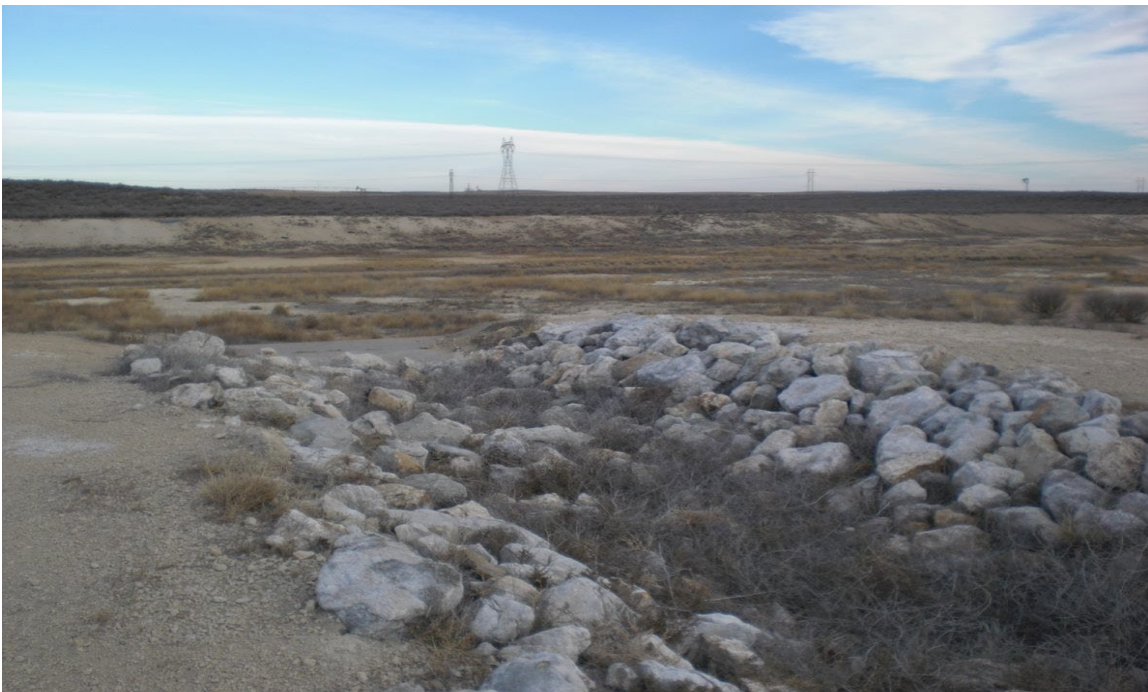
Photo 4: East end of contact water ditch to evaporation basin
